PLANNING COMMITTEE

SUMMARY REPORT GOLDEN RAIN FOUNDATION PLANNING COMMITTEE

Traffic Safety Phase 1 Alternate Proposal

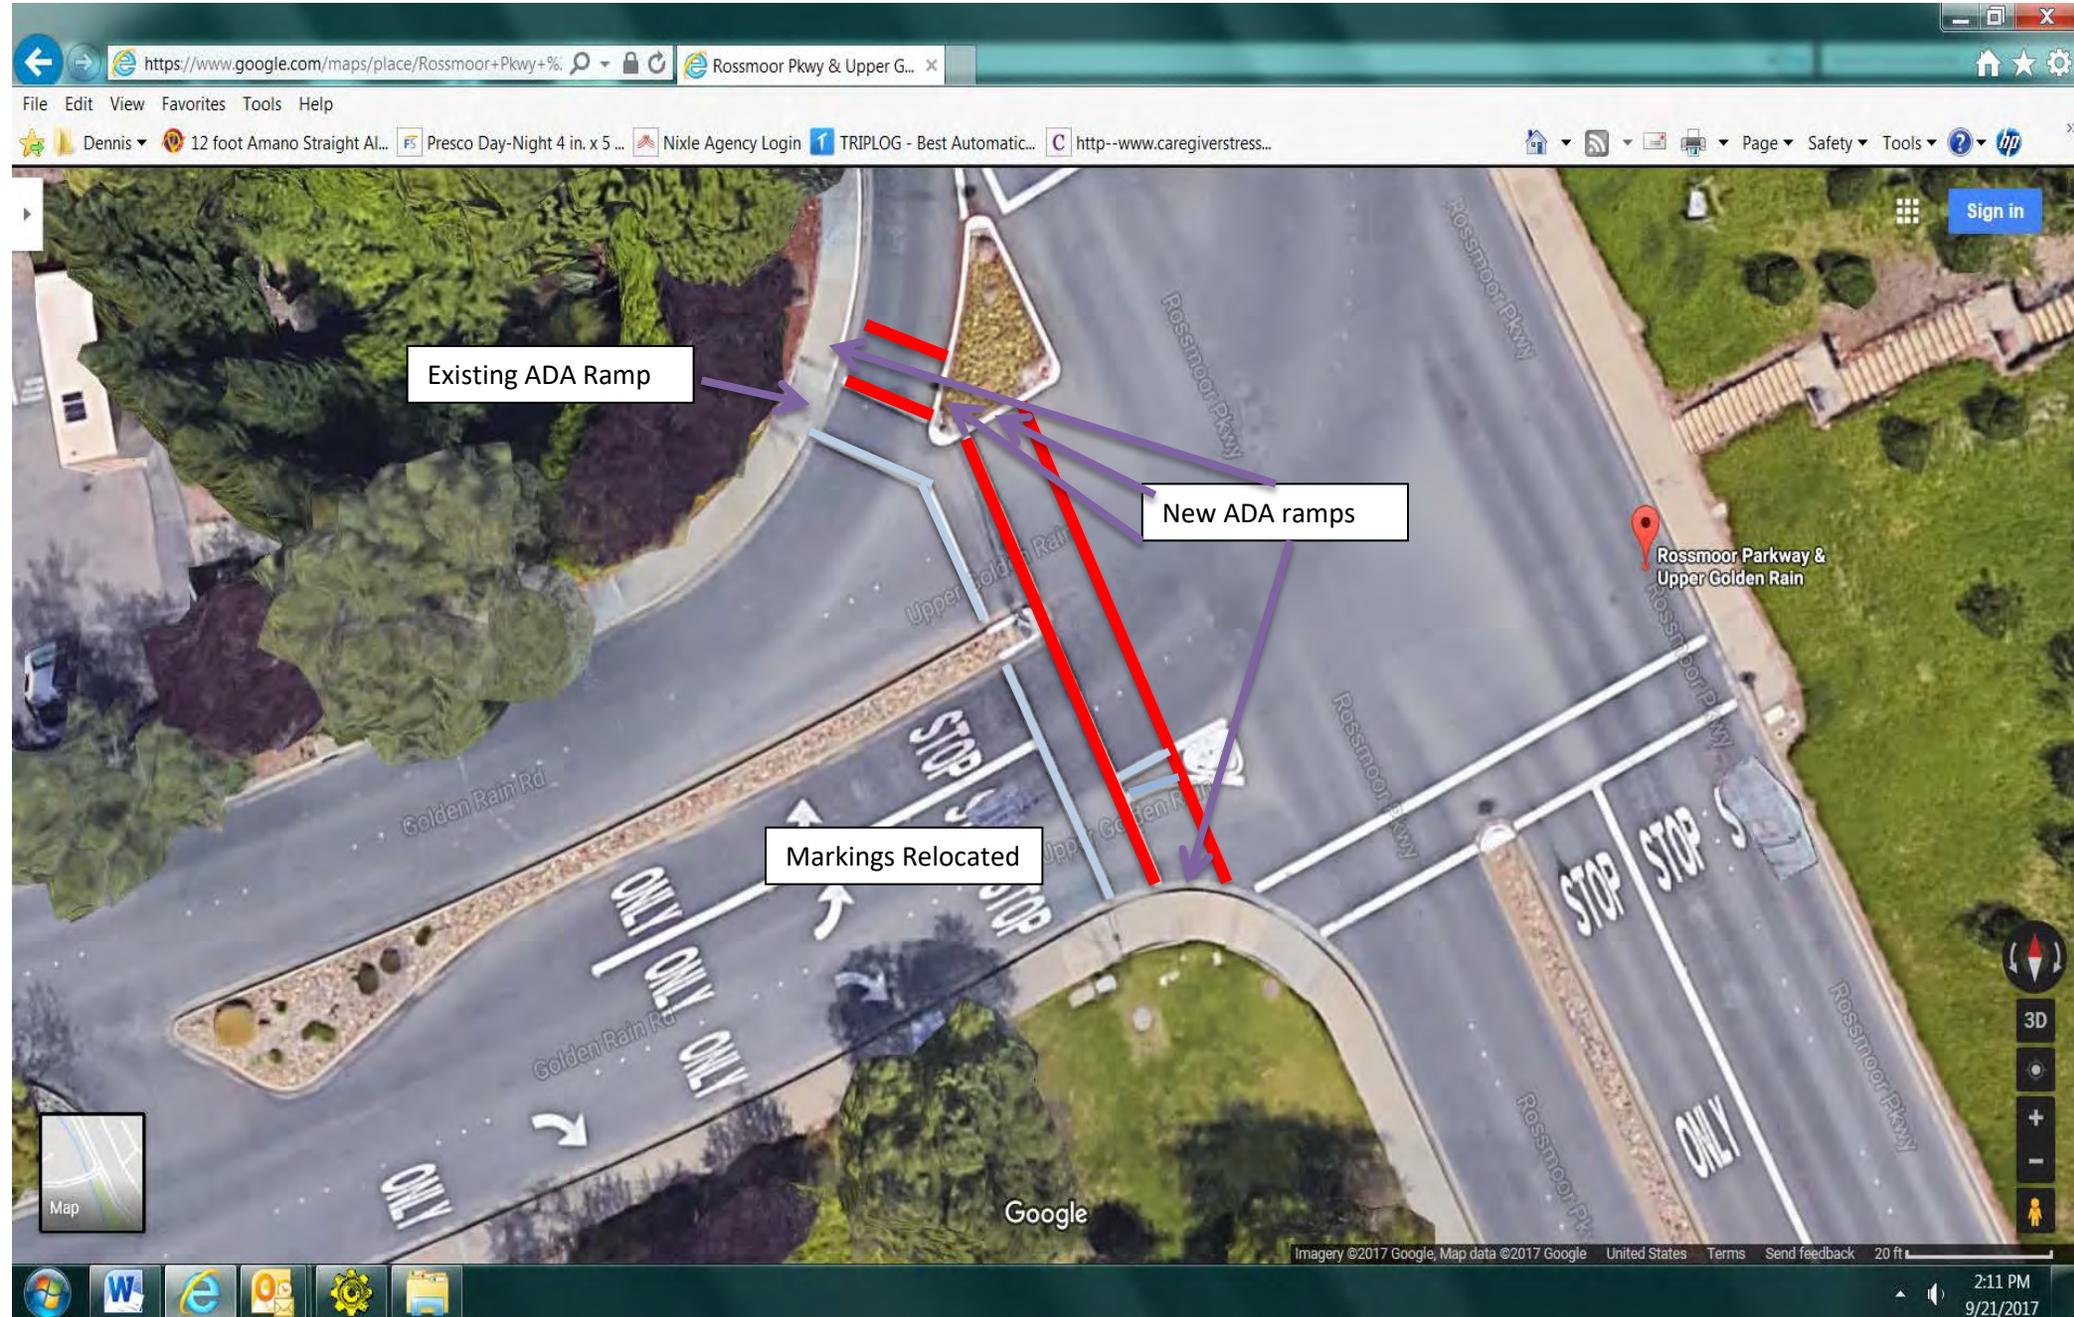
6a-5

Red lines show location of new crosswalk. Grey line is the existin crosswalk.

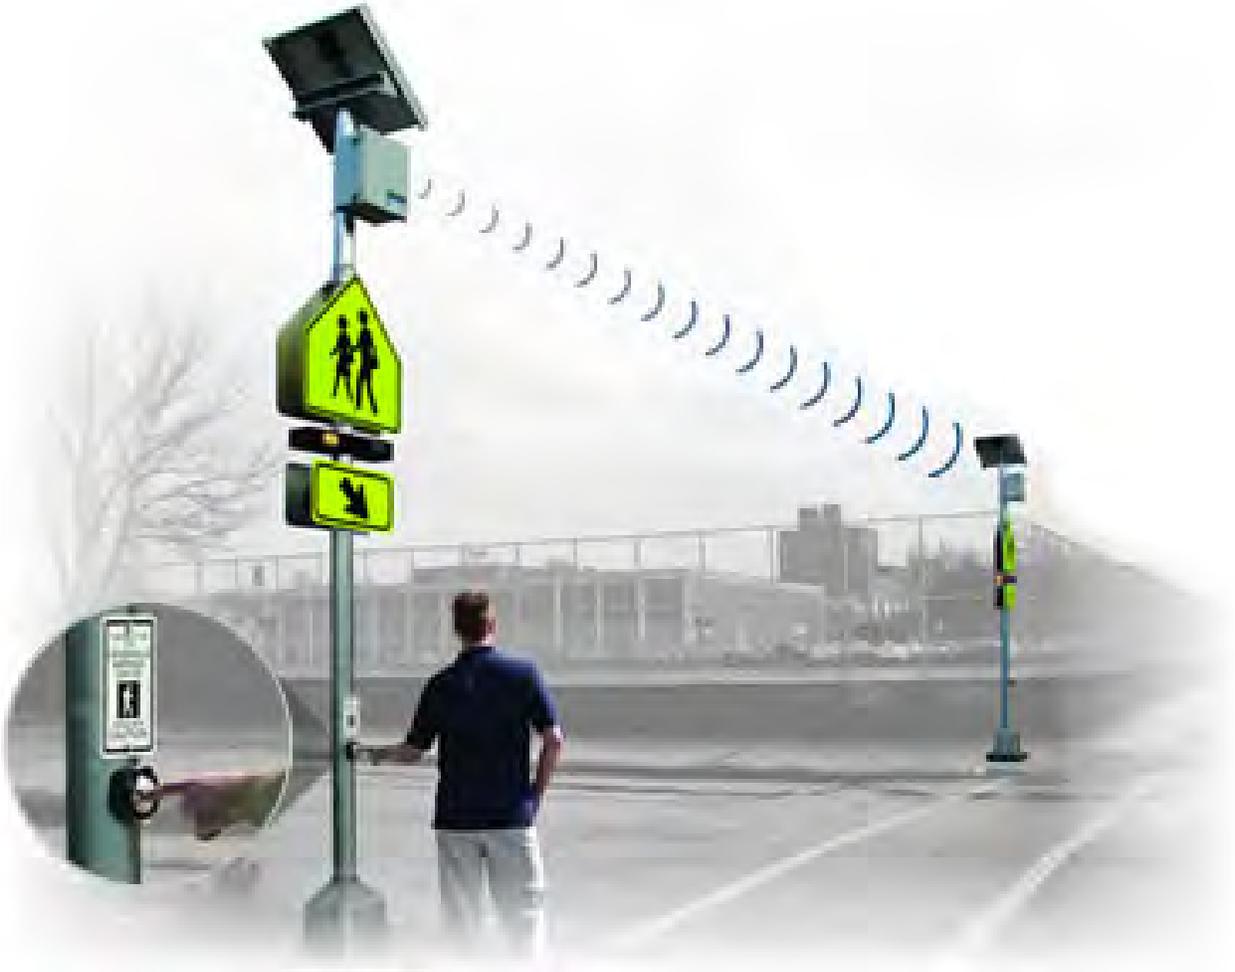
Attachment #3

Example of a solar powered, wireless, pedestrian activated RRFB

Staff Recommendation: Staff recommends installing two solar, wireless activated RRFB's for the crosswalk on Tice Creek Dr. at Oakmont Dr.

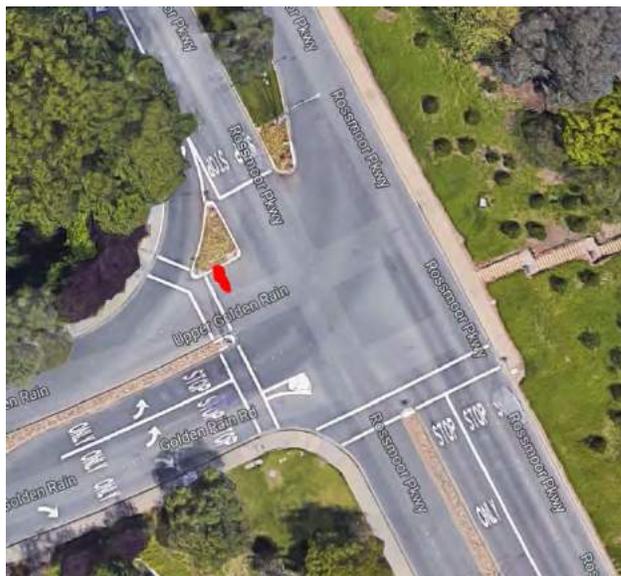
S-2 This site has high traffic volume. It has some unique problems. When approached from Golden Rain (eastbound), drivers do not have a clear picture of which northbound lane cars are in because the Golden Rain roadbed is lower. This creates some right of way confusion. Being a two-lane T intersection some cars in the northbound #3 lane feel that they have the right of way. Golden Rain left turning traffic often does not stay in its lane. Usually it is the #2 lane traffic turning into the Rossmoor Parkway #1 lane (left) which is the lane they are legally supposed to use. Northbound left turning will often turn into the Golden Rain #2 lane interfering with the Rossmoor southbound left turning traffic. This creates a bad merge problem. Installing a barrier across this lane as indicated in red below along with a “Keep Left” sign will fix the problem. This will also make the crosswalk safer.

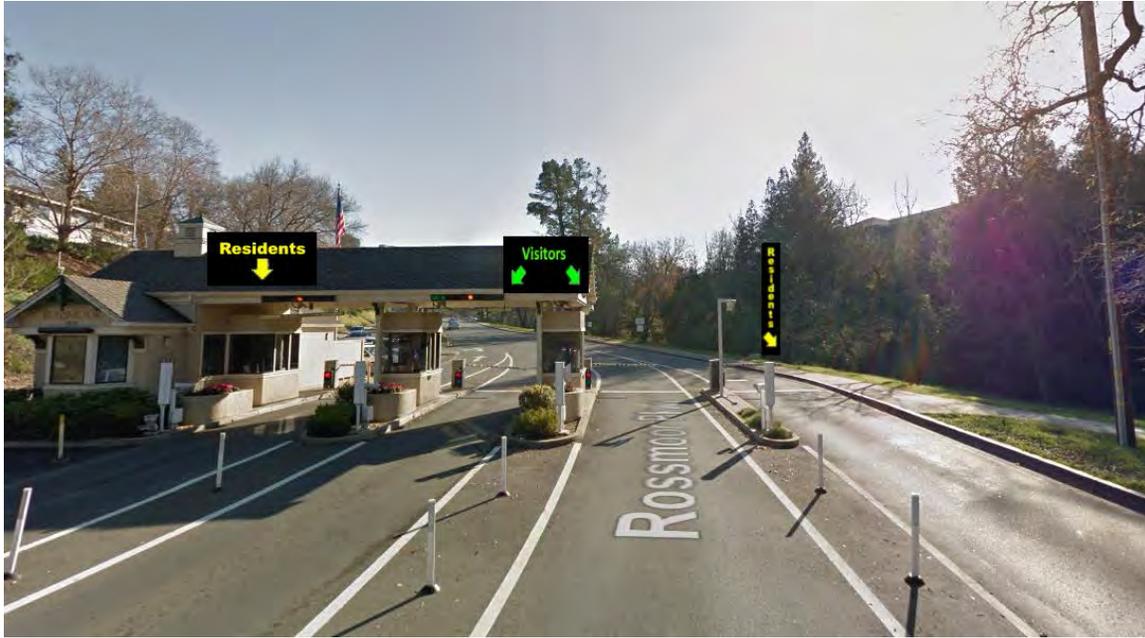
S-1 This was listed as more than 1/3 of the accidents but was not listing as a priority. Directing people to the right lanes when entering is a problem and possibly we need other bright minds to work on the problem. We might also need to conduct some trials to determine if a reconfiguration that will reduce the post gate cross merging will work. Even shifting visitors to gates #2 & #3 might help. Residents would use #1 & #4. Gate #3 would accommodate over sized and commercial vehicles and no lanes would be any further than one lane from a guard. Above guardhouse #3 would be a big sign. A visitors sign with arrows pointing to lanes #2 & #3. The visitors portion would be lighted and the two arrows could be individually lit when one lane is closed.

Traffic entering would have a sign on the left “South/East Rossmoor via Rossmoor Parkway” The one on the right would say “North/East Rossmoor via Golden Rain Road”. The oversized vehicle warning sign would stay. The #1 & #4 lanes would be marked on the asphalt “Residents Only” The middle lanes would be marked “Visitors”. In any case visitors would never be more than one lane off and it would eliminate the problem of left merging traffic trying to merge with right merging traffic. The problem with this is that visitors backing up at the gate may block traffic for residents and emergency vehicles especially for the right lane, which due to the creek splits a short distance from the gate. This may mean just passing visitors through the gate without checking when the backup gets too bad.

We could start by re-striping the lanes so that the left lane splits into gates 1 & 2 and then the right lane into gates 3 & 4.

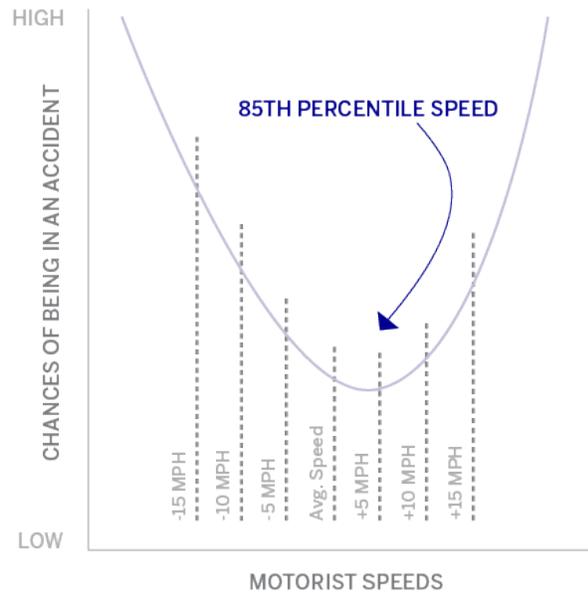
ACCIDENT INVOLVEMENT VS. MOTORIST SPEEDS

Source: "Speed Zoning on Texas Highways" State Department of Highways and Public Transportation, Austin, Texas, October 1990

In setting speed limit the starting point is the 85% speed. This is based on the fact that most drivers know what speeds are safe to drive and speed limits should reflect safe driving speeds. Guidelines allow under special circumstances to set speeds as much as 5 mph lower but when we can clock drivers safely driving at speeds as high as 37 mph this is an indication that no matter what we do this road will never be safe for all golf carts.

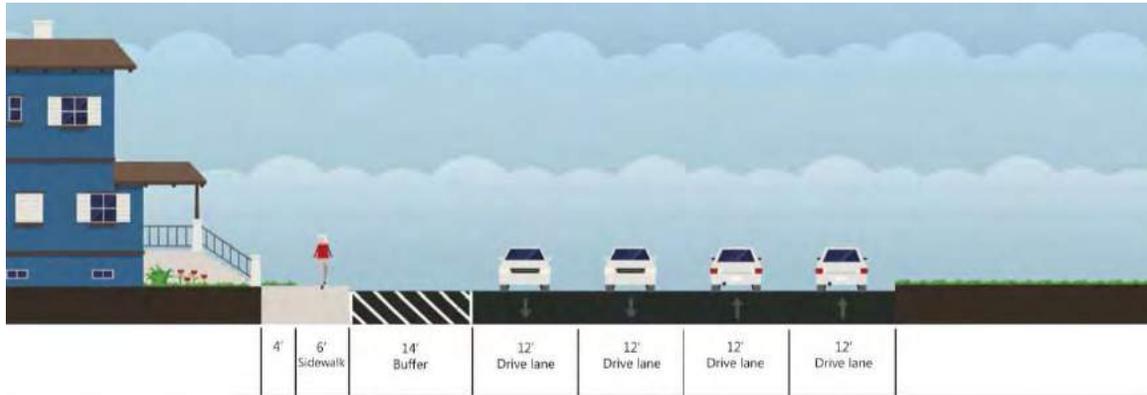
Existing roadway at the widest point.

Not only is it unsafe for golf carts to use some of our roads such as Golden Rain Rd between Tice Creek and Pine Knoll but while it has a buffer between intersections it has less room at the intersections.

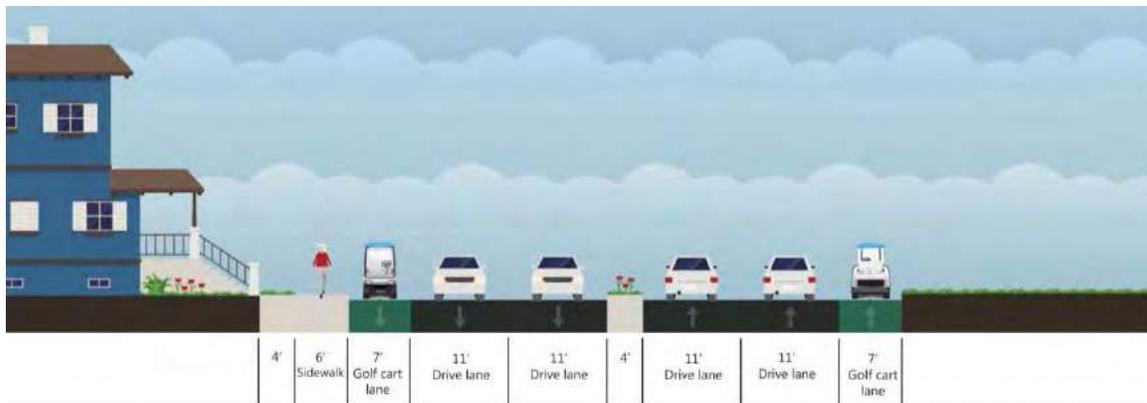
Proposed golf cart lanes, 11' car lanes and 4' center lanes at widest point.

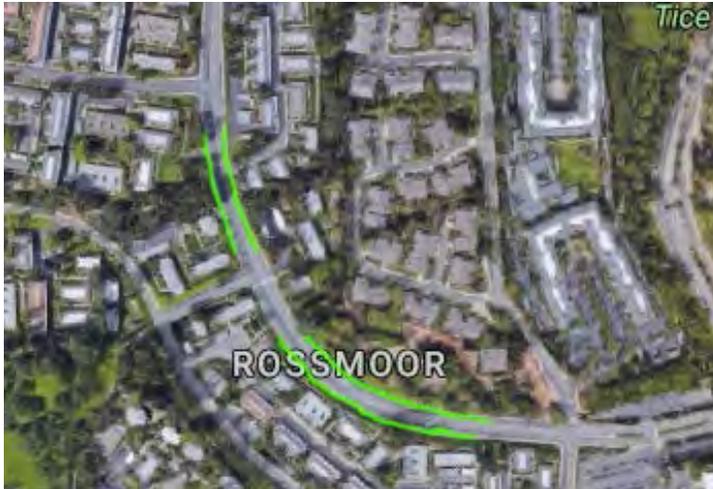
Portions that can be configured for golf lanes (in green)

At the intersection of Tice Creek there are 5 lanes with the turn lane and a center median. Eliminating the left turn lane will misalign the intersection. The eastbound golf cart lane will have to merge before the intersection. The westbound golf cart lane will have to start a ways after the intersection. At the intersection of Oakmont the road narrows. Instead of the 14' buffer on the side there is a center median about 5' wide. This is a loss of about 9' of total road width requiring that the westbound golf cart lane merge back into traffic before the intersection. The same problem exists at Pine Knoll. In other words the golf cart lanes can only run some of the distance between the intersections.

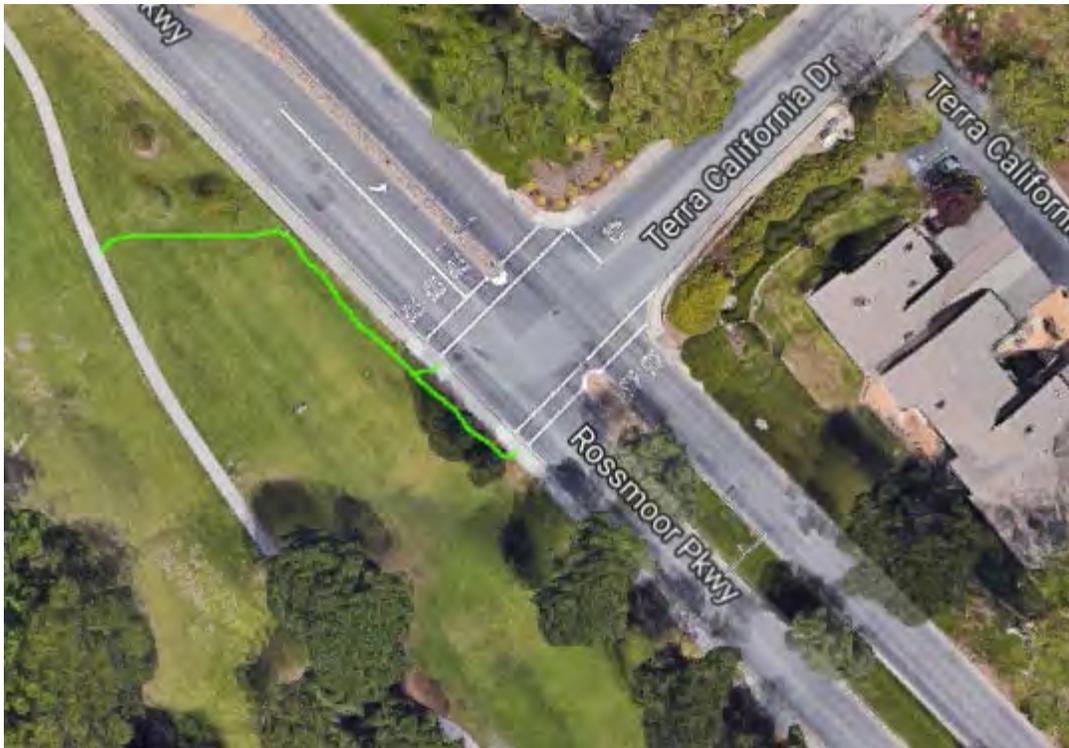
Path from the north end of Terra California around the tee to the existing path. There should be room to squeeze around the fire hydrant.

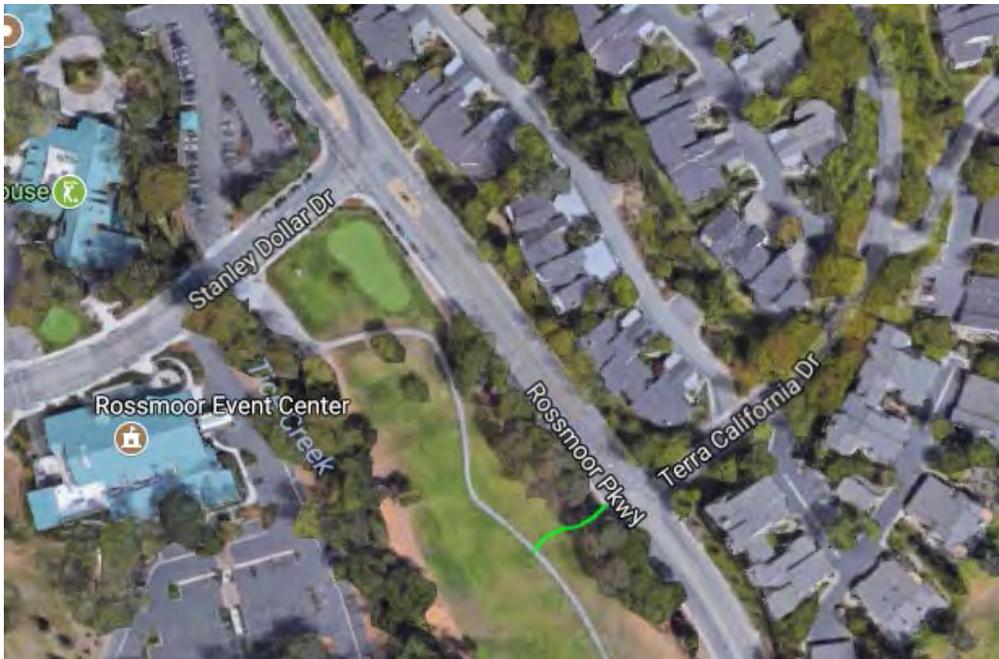
At the south end of Terra California add a path to tie into the existing path.

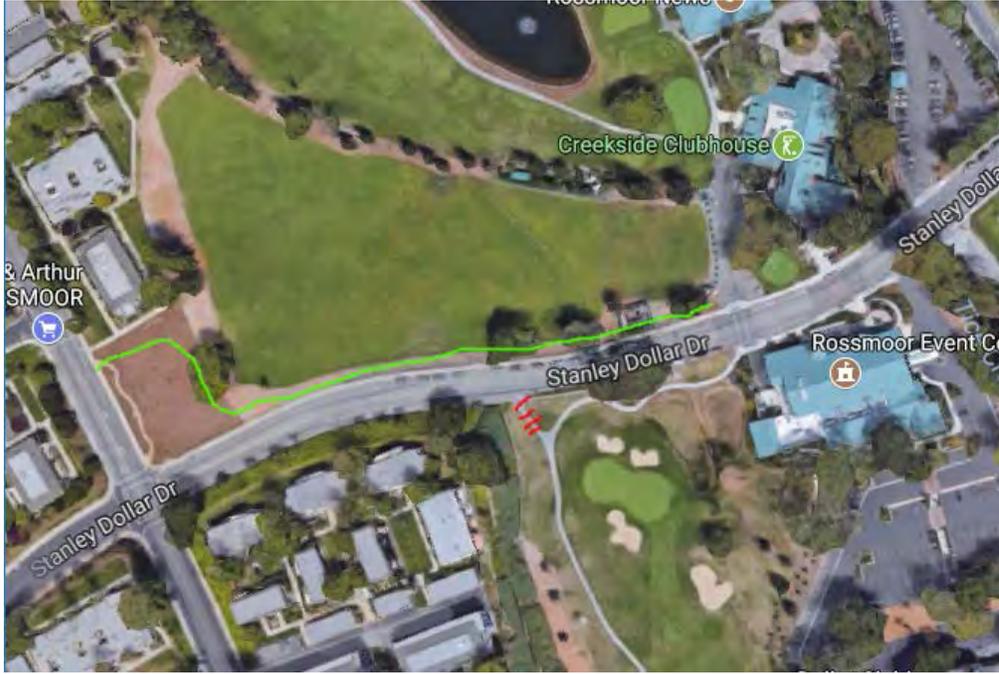
Add a path from Creekside to Tice Creek entering a distance for the intersection. Remove the dogleg. This is not because of the vehicle speeds but because of the number of golf carts currently using this stretch of Stanley Dollar
